# Current Status of J-PARC Facilities

October, 2011

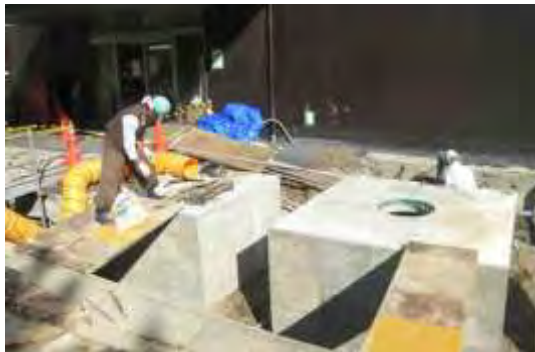
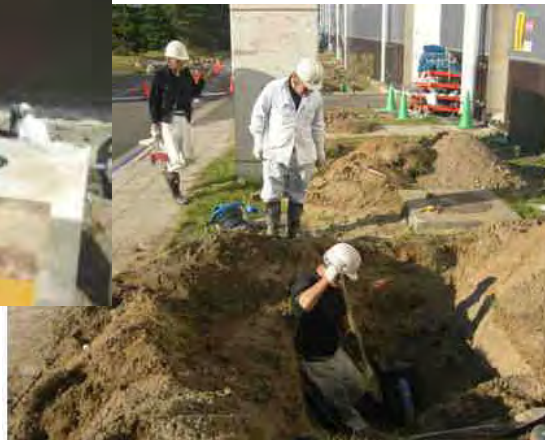
## Replacement of Catch Pit, and Supply and Drain Pipes

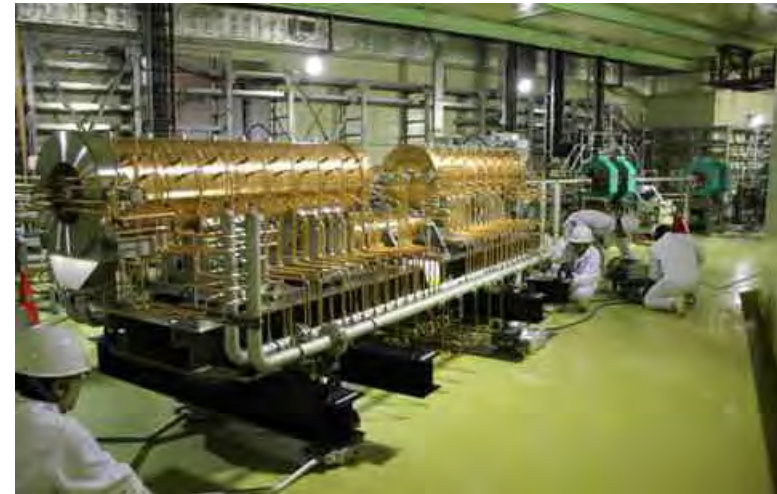
Installation of ACS in Tunnel

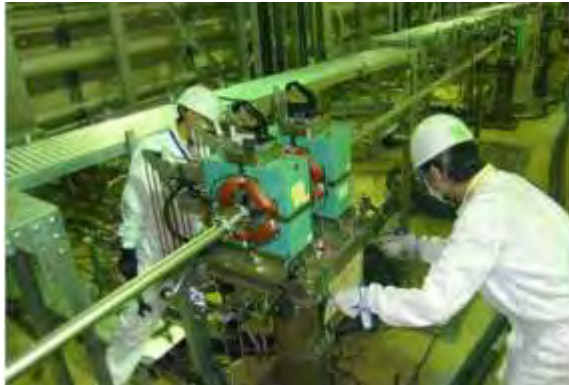
Alignment of L3BT electromagnets

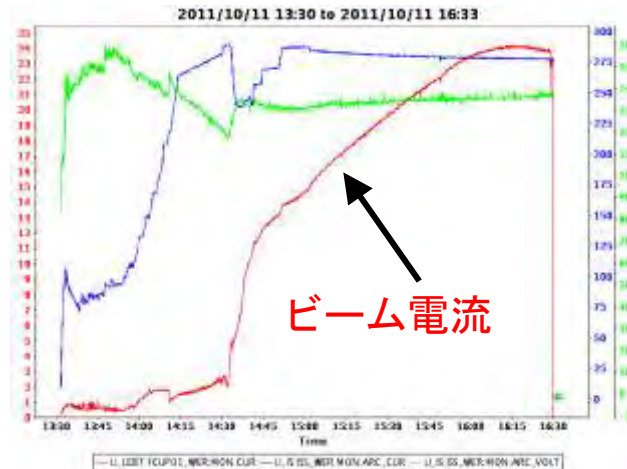
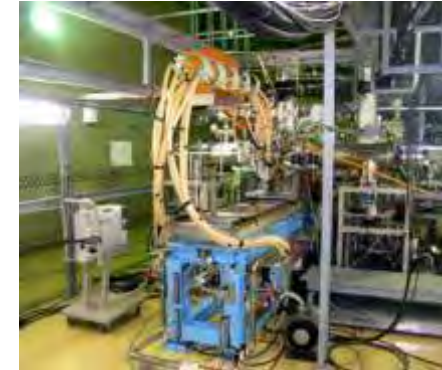
Ion source (above);  
The beam current reached to 24 mA within three hours (left).

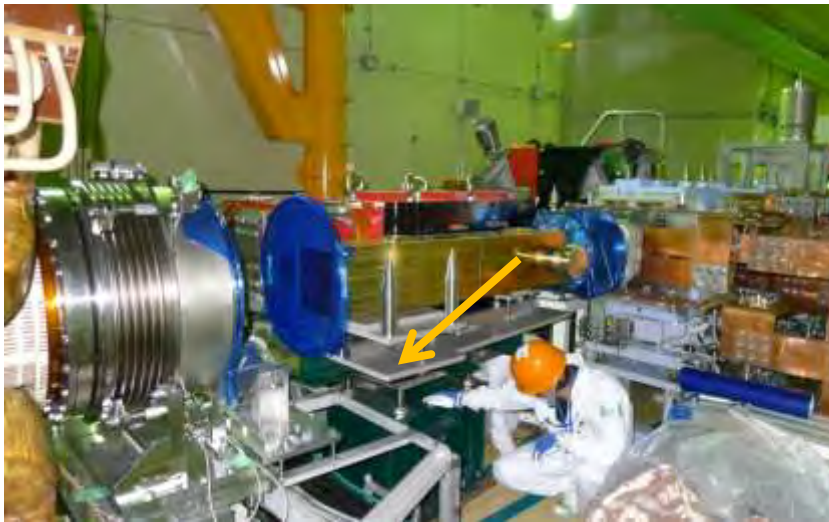
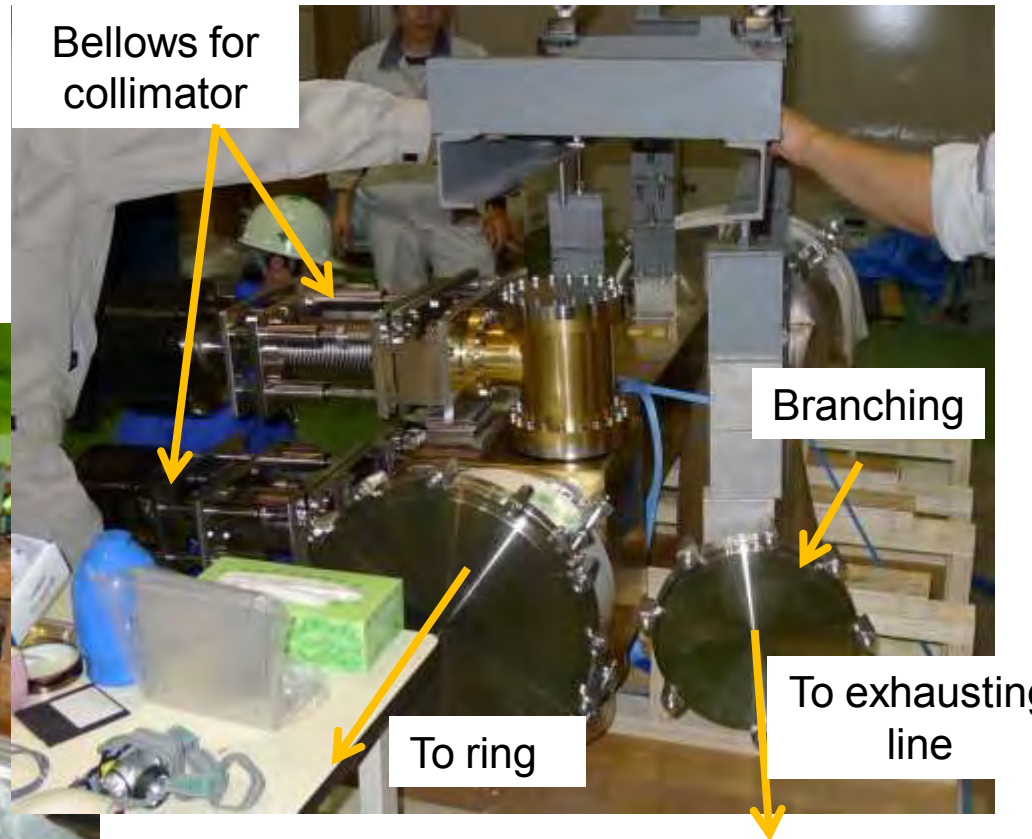
Installation of New Collimator

The collimator has been installed without breaking vacuum, and baked after the installation.

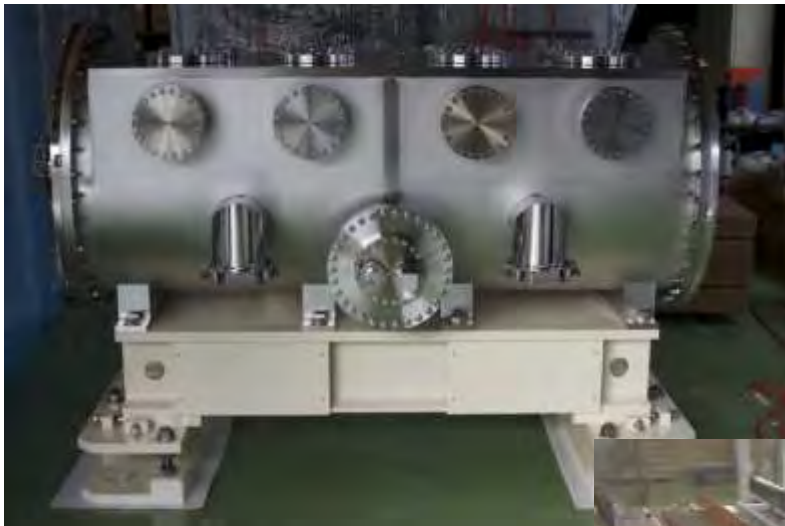
Vacuum chamber of the new injection-kicker magnet (above); Mount for the new magnet (right)

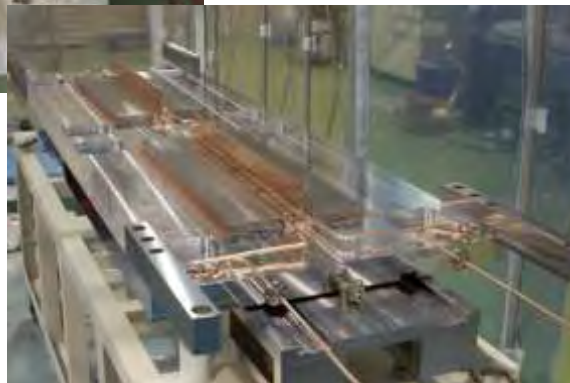
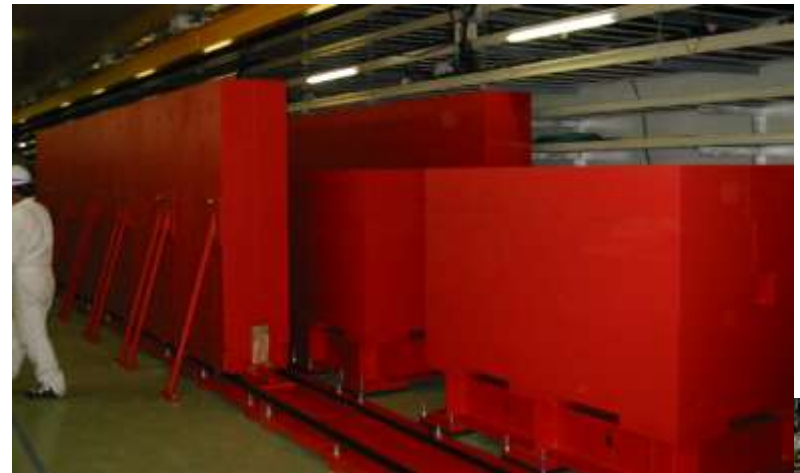
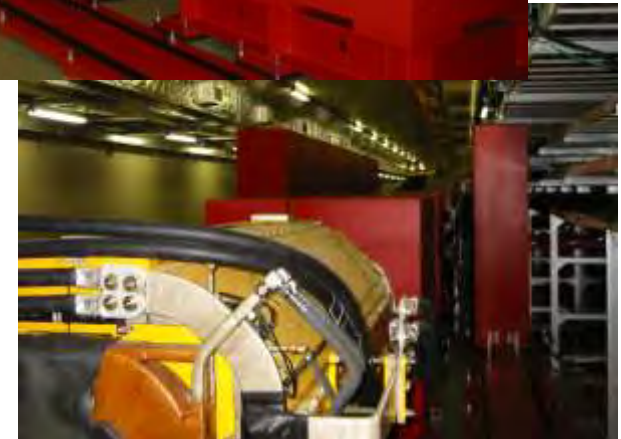
New absorbers and wall-type shields in ring-collimator area

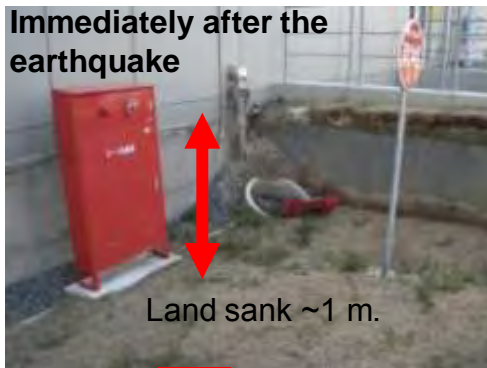
Piping system around the building was heavily damaged.

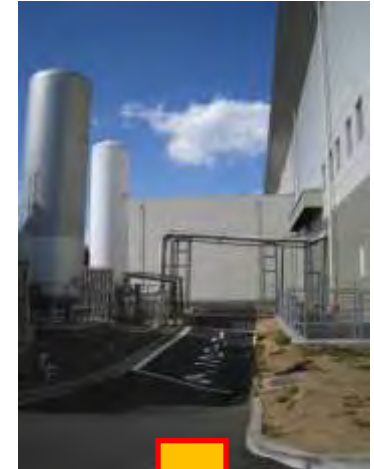
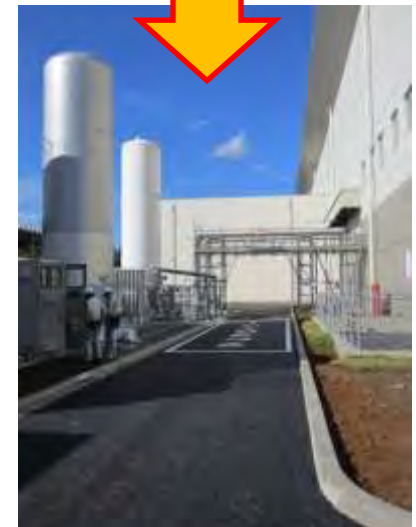
Tilted liquid He tanks were straightened. The surrounding road was also restored.

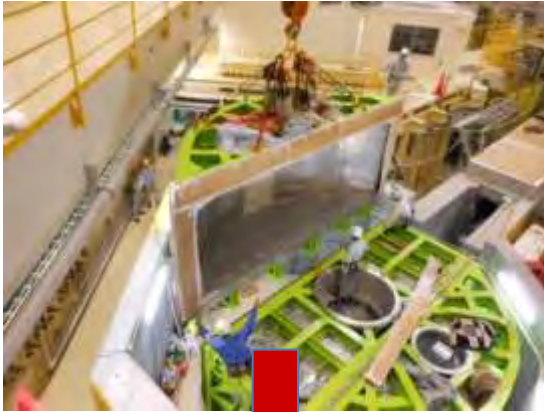
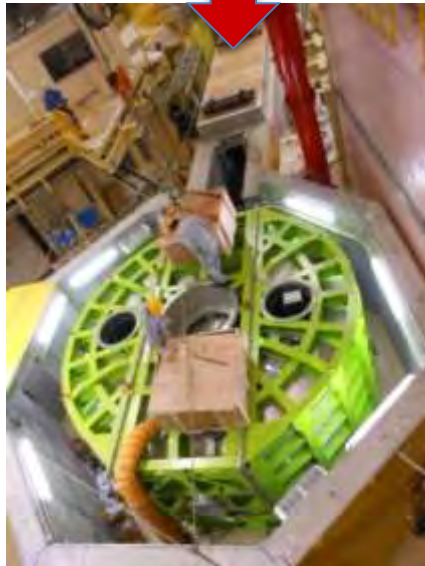
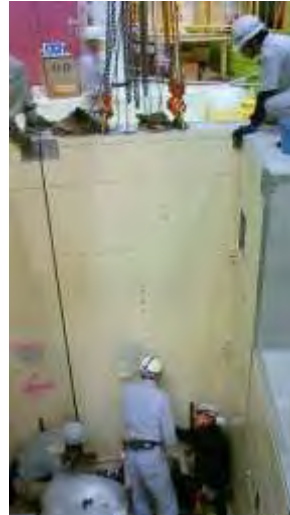
Measurement and marking in the western extension building →

← Re-installation of shielding block (BL17)

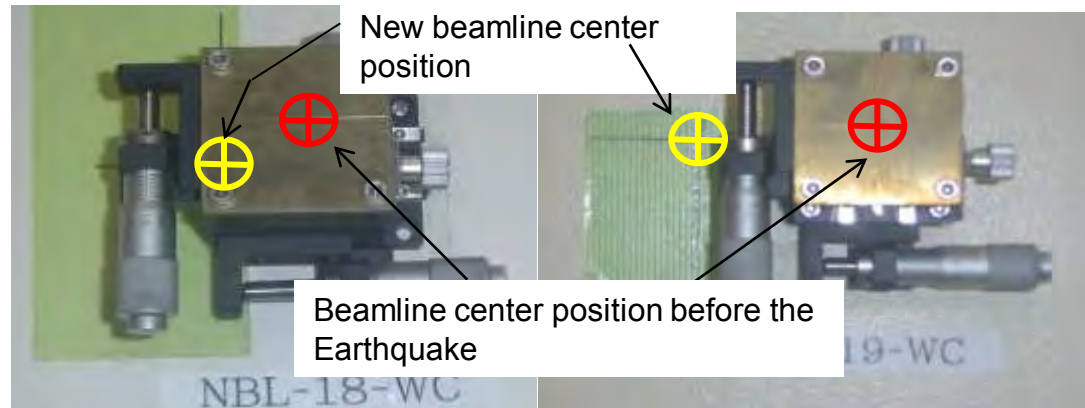
Beam center displaced more than 30 mm depending on a place of the western extension building. New plates were installed.

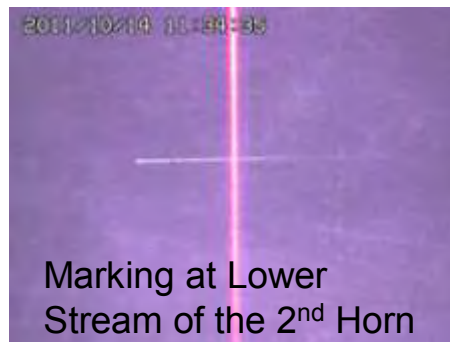
Marking at Lower Stream of the 2<sup>nd</sup> Horn

Displacement of Horns (mm)  
2<sup>nd</sup> Horn:  $0.0 \pm 0.3$ , 3<sup>rd</sup> Horn:  $0.3 \pm 0.3$   
(No displacement)

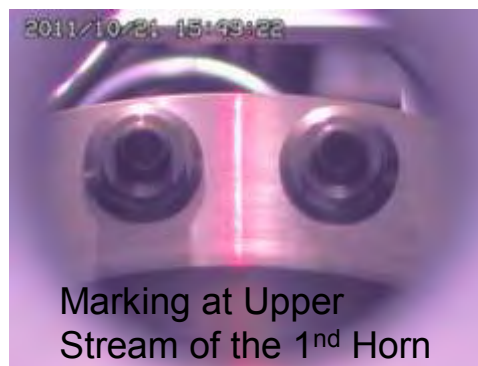
Marking at Upper Stream of the 1<sup>st</sup> Horn

Displacement at lower stream of 1<sup>st</sup> horn is  $< 1$  mm.

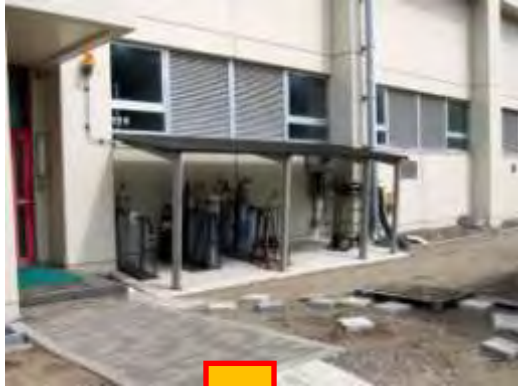
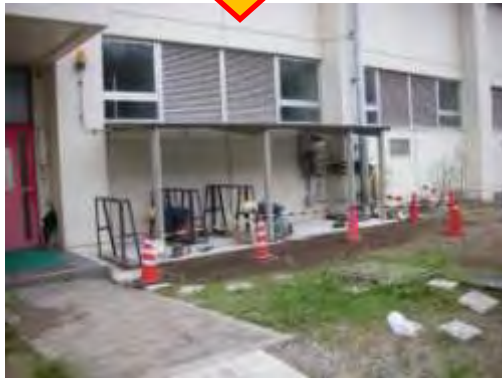
Restoration work near cylinder stands was completed.

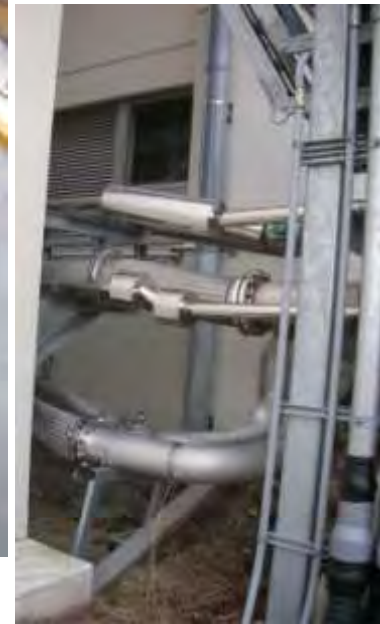
↑ Started to repair distortion in the cooling water piping system
