# Current Status of J-PARC Facilities

October, 2011

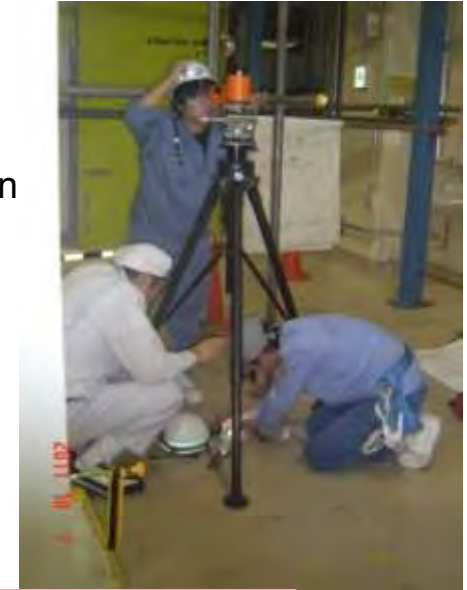
*XY stage of BL18 wall*

*XY stage of BL19 wall*

Beam center displaced more than 30 mm depending on a place of the western extension building. New plates were installed.

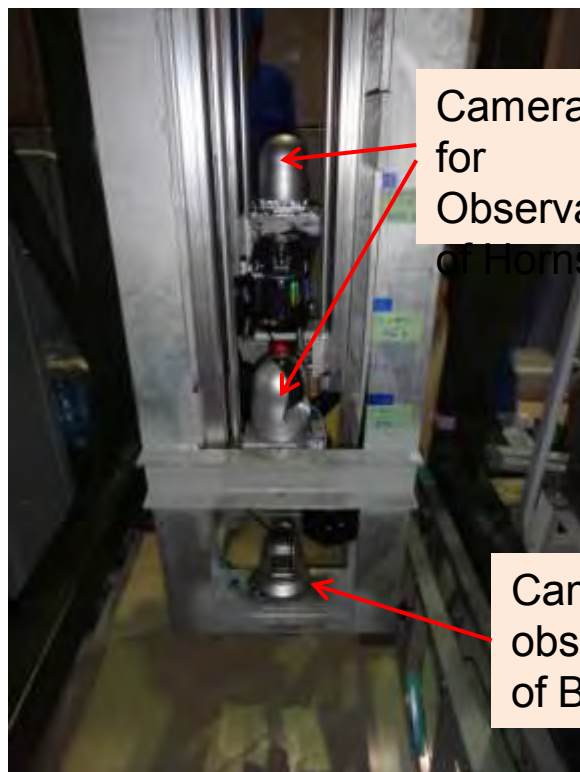
Cameras  
for  
Observation  
of Horns

Camera for  
observation  
of Basement

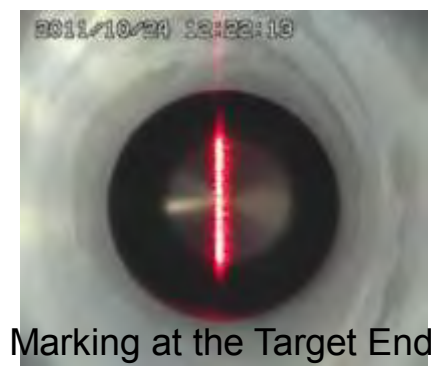
Marking at the Target End

Displacement at lower stream of 1<sup>st</sup> horn is  $< 1$  mm.

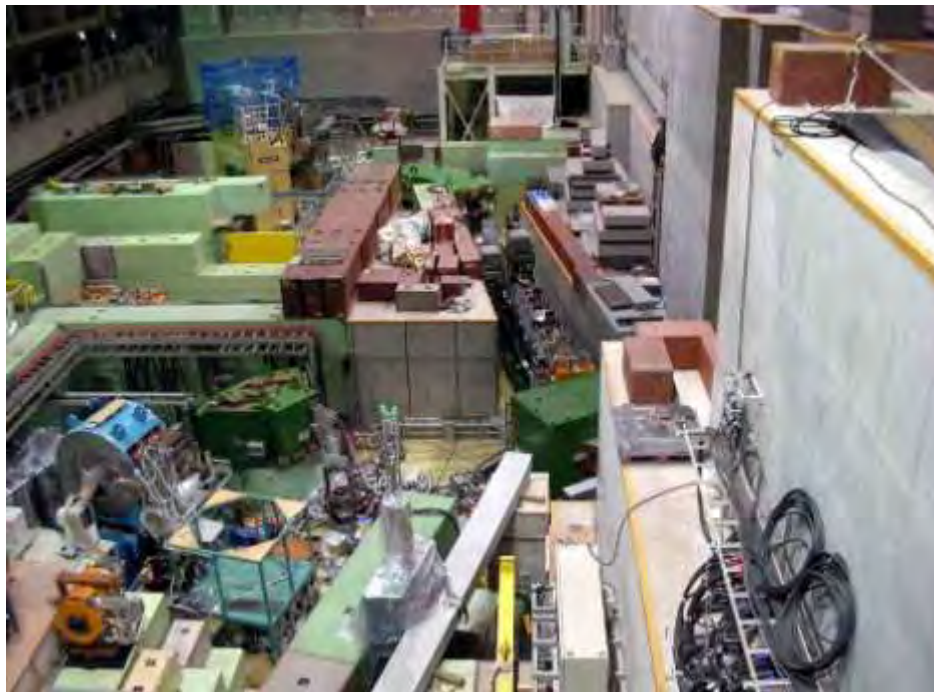
Hadron Experimental Hall (North)

- Almost all recovery work of damages around building was completed.
- Alignment and other recovery work in the experimental hall go smoothly. Re-installation of shielding blocks continues.
